Monitoring Data RecordProject Title: U-4026B (Davis Drive) COE Action ID: 200120448Stream Name: Tributary to Burdens Creek (Site 9) DWQ Number: 051972City, County and other Location Information: Durham County, Davis Drive (Sta. 284+50RT.)Date Construction Completed: 12/5/07 Monitoring Year: (4) of 5Ecoregion: _____ 8 digit HUC unit 03030002

Tributary to Burdens Creek

Year 4 Summer – July 2011

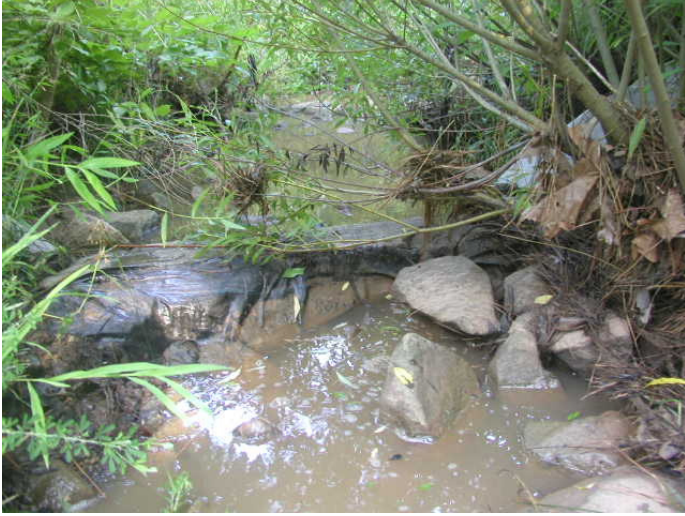
Rock Sill @ Sta. 285+60-L- (downstream of PP#3)

The Tributary to Burdens Creek is stable for Year 4 Summer evaluation. A bankfull event has occurred since last monitoring evaluation. A rock sill at Sta. 285+60-L- (just downstream of photo point #3) had water piping through this structure at the time of the evaluation. NCDOT will continue to monitor this stream relocation.

Date Inspected 7/7/11	Station 285+60-L- (additional photo)	Station Number	Station Number	Station Number	Station Number
Structure Type					
Is water piping through or around structure?	Water piping through rock sill				
Head cut or down cut present?					
Bank or scour erosion present?					
Other problems noted?
